SITE CERTIFICATION SUMMARY

This Site Certification Summary provides information about the **Berkeley, California, Site**. The U.S. Department of Energy Office of Legacy Management is responsible for long-term stewardship of the site under the **Formerly Utilized Sites Remedial Action Program**.

Berkeley, California, Site Certification Data Summary Worksheet

Berkeley, California, Site Map

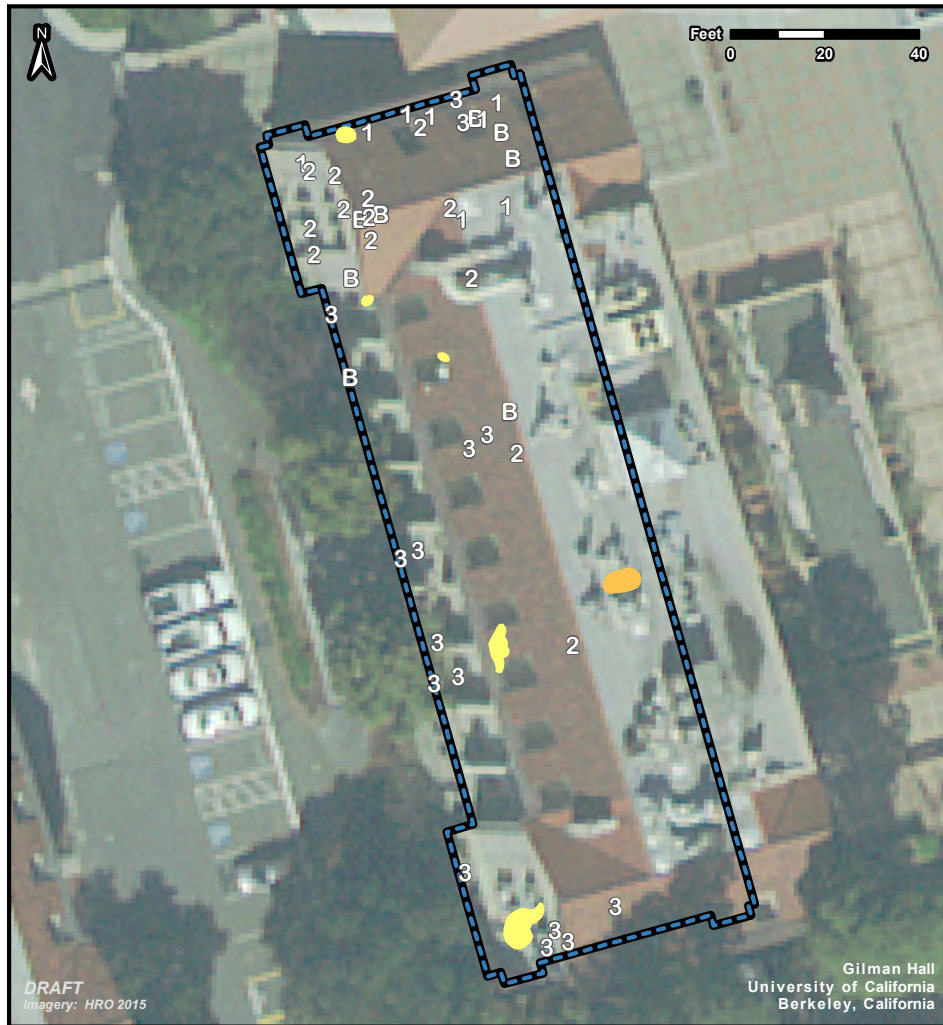
Remediated Contamination

Found in 1976 (DOE)

Found in 1981 (UC)
